Existing Conditions on Main Street :

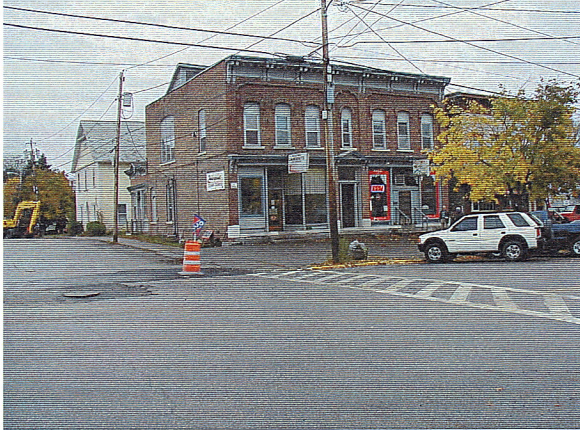
1. Sidewalks: There are a variety of sidewalks ranging from the historic slate sidewalks that are mostly in poor condition and dangerously slippery in wet weather, to asphalt sidewalks laid over either slate or concrete replacement sidewalks – also in poor condition, because deteriorated sidewalks are underneath – and relatively new concrete sidewalks that are in acceptable condition. Town officials feel strongly that sidewalk replacements are among the highest priorities for the Main Street improvement plan. The design plan suggests that different treatments of sidewalks should be defined because of the varied land uses and frontage conditions as this map demonstrates.

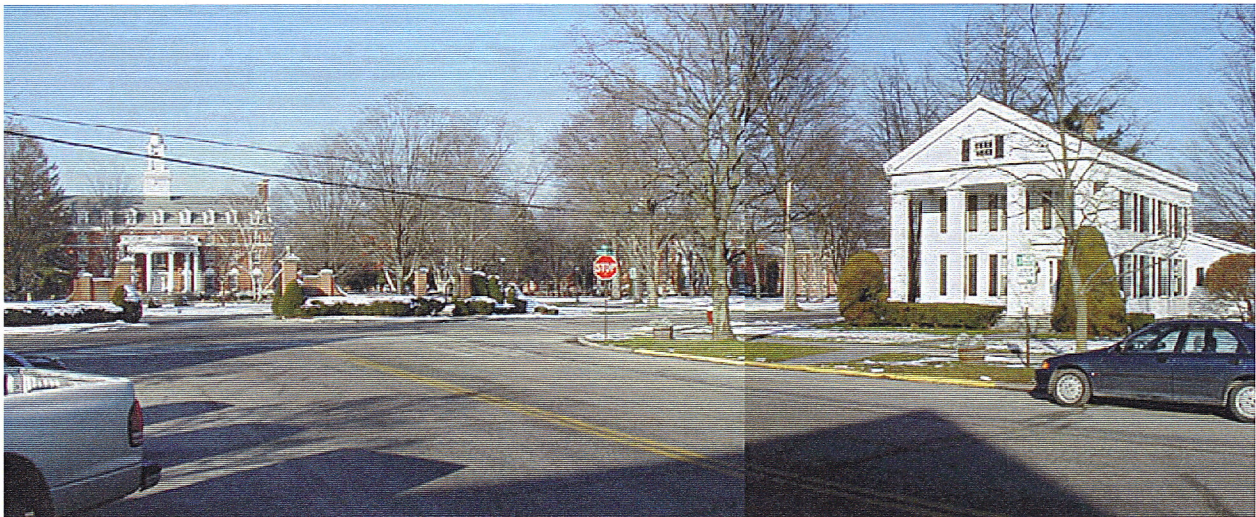
College and Main:

This intersection is a visual focal point between the downtown and the college and needs to be treated as a gateway to the downtown from NY State.

- Crosswalks are only on one side of Main Street and the sidewalks do not connect on both sides into the campus
- College Street tends to have fast traffic bypassing the downtown en route to NY State.
- Traffic calming is needed to slow speeding cars.
- Better defined pedestrian zones to encourage safer crossing patterns and delineate a slow auto zone.
- Slate trucks and other heavy vehicles use College Street.

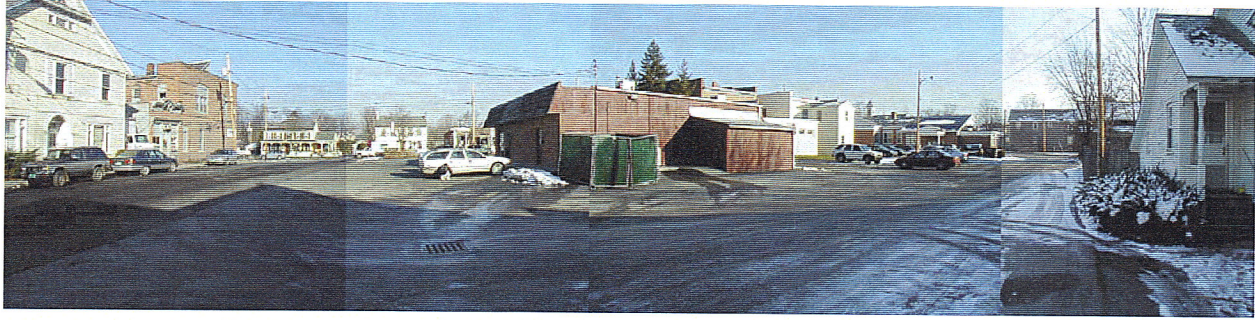
Maple and Main:

- Heavy vehicles use Bentley Avenue and connect to the downtown on Maple Street.
- The Bentley Ave. improvements connected to Main Street to replace some sidewalks but the Main Street – Maple Street intersection has some of the most deteriorated sidewalks in downtown.
- There are excessively wide turning zones that have ill-defined corner setbacks for sight distance and wide undefined pedestrian crossing zones. Crosswalks are in need of improvement.
- The corner near Stewarts is dominated by the Stewarts driveways and sign, both an unattractive as well as confusing traffic pattern location.
- Sidewalks are non-existent along the east side of Maple Street across the Stewarts frontage.

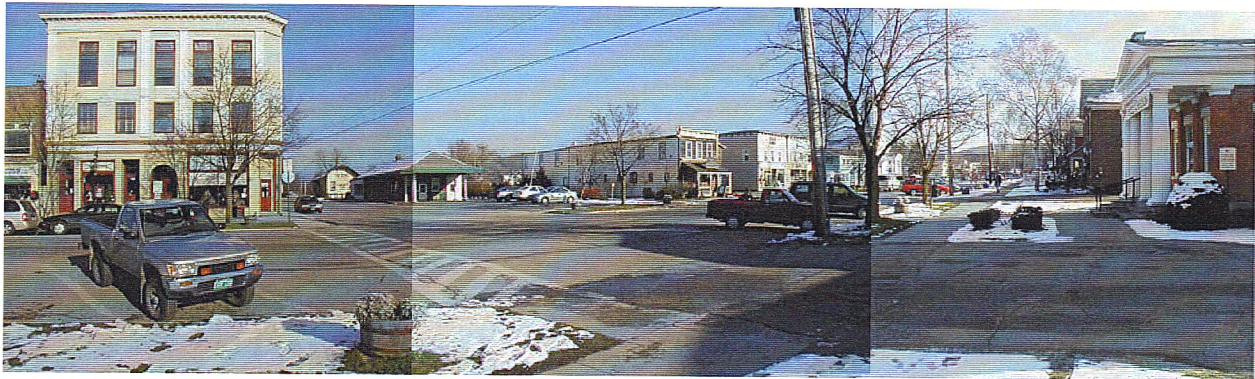
Depot and Main:

This is regarded as the most unsafe intersection in downtown, due to the wide street crossing and the very confusing traffic patterns entering and exiting the bank. Depot Street is very wide and does not have designated on-street parking, which would be an asset for on-street parking availability as well as traffic calming with a slower, narrower road. This intersection defines the center of activity for the downtown, yet the current configuration does little to signify that role.

It appears that while requested by residents, neither a stop sign nor a traffic signal would be appropriate for this intersection. The relatively low traffic volumes would not likely pass the required warrants for signal control and STOP signs would create severe congestion on the street and a disruptive pattern of stop-and-go for drivers that is unjustified on most occasions. The design team suggested that simpler improvements in the form of traffic calming and pedestrian improvements could solve the same problems that have been perceived by residents.

Cooperative efforts with the bank need to be established to reconfigure driveway patterns and parking for the bank which are the root cause of confusion and safety problems at the intersection. The bank should allow entrance only at the driveway and exiting via the back alley onto Maple Street behind Stewarts.

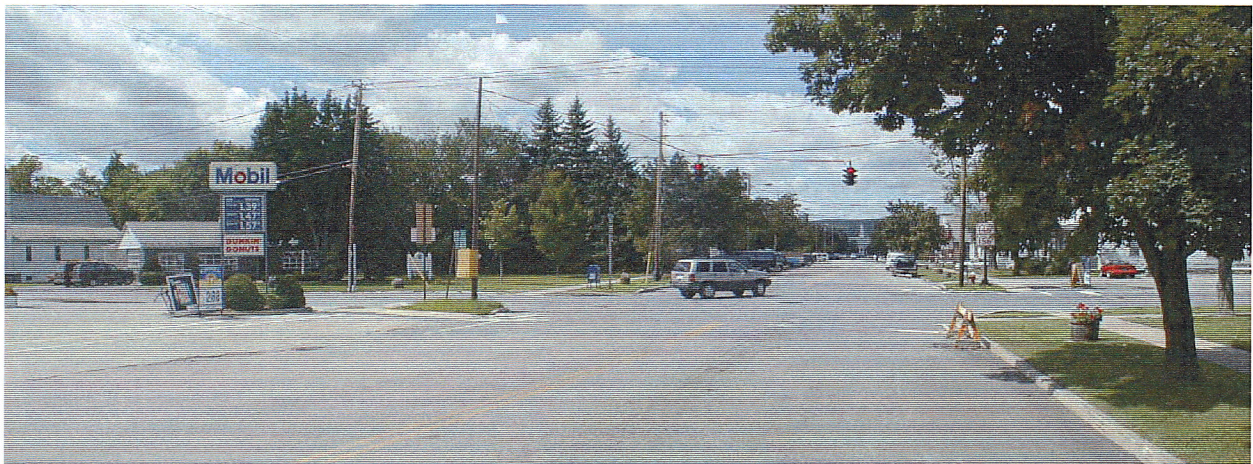
View to Vermont RT 30 and down Main Street from East Main Street. Two of the four corners are dominated by gas stations with wide curb cuts and auto-oriented frontages.

This is the most heavily traveled roadway entering Poultney, and the intersection of Main Street and RT 30 is the most important place to advertise the downtown, and to set the expectations for automobile drivers to slow down in the center of town. The intersection of RT 30 and Main Street is marked only by a traffic signal and the town office building.

- Gas stations are the dominant landuse on two corners.
- The entrance to downtown is all but invisible.
- Sidewalks are non-existent along the east side of RT 30 along the Citgo and Mobil frontage.
- There is a profusion of convenience store and gas station sales signs.
- Excessively long curb cuts are above state standards for access management.
- Sidewalks vary in condition, width, etc.
- Uncontrolled access at service stations detracts from the pedestrian friendliness.
- Considerably fewer street trees and landscaping.

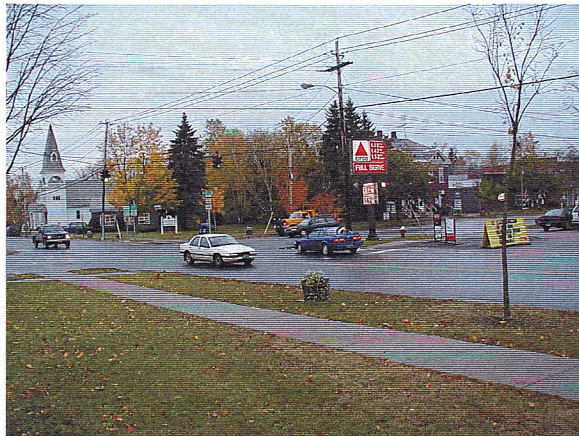
View to the Main Street/ Vermont RT 30 signalized intersection.

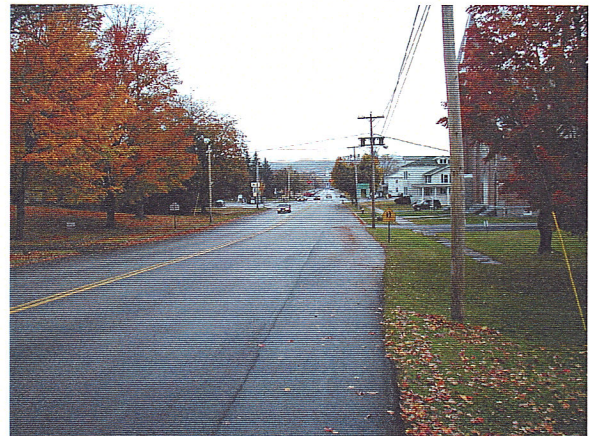
View to Vermont RT 30 and down Main Street from East Main further back – this is the same view location as can be seen on the report cover page.
